## BLACKFEET COMMUNITY WATER PROJECT

September 5, 2002

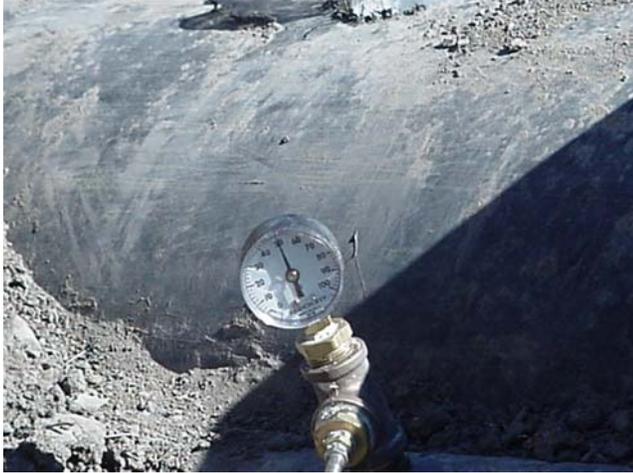
4" HDPE airline that will be used to clean intake screen when required meets pressure test requirement. Line held 50lb psi for over 24 hours.

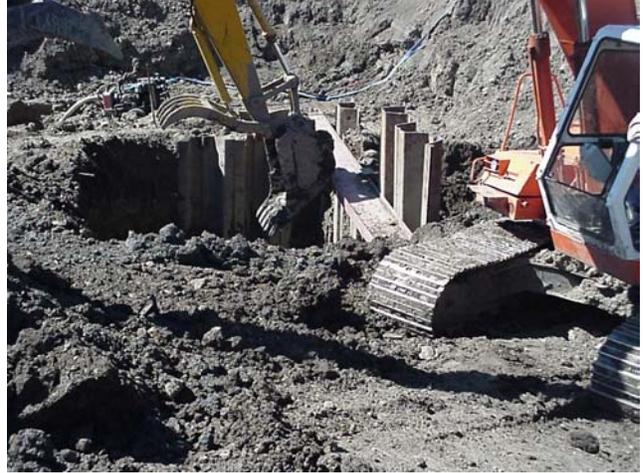
Sheet piling has been driven another 12' to excavated surface. Interior has been excavated another 15'. At approx. 27' below surface level, the soils are damp but no ground water has shown.

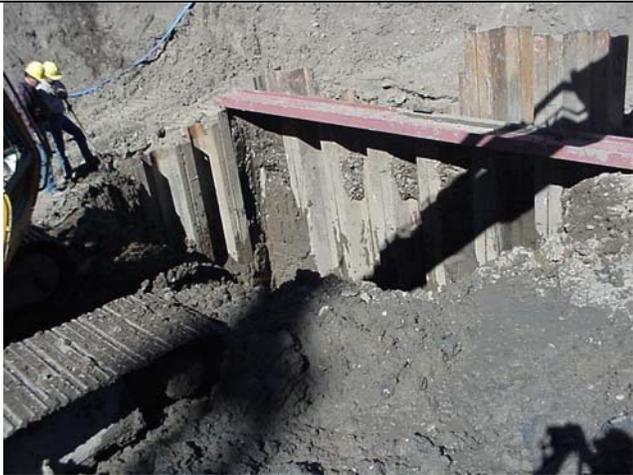
This view shows the structural support of the sheeting being installed to prevent collapse.

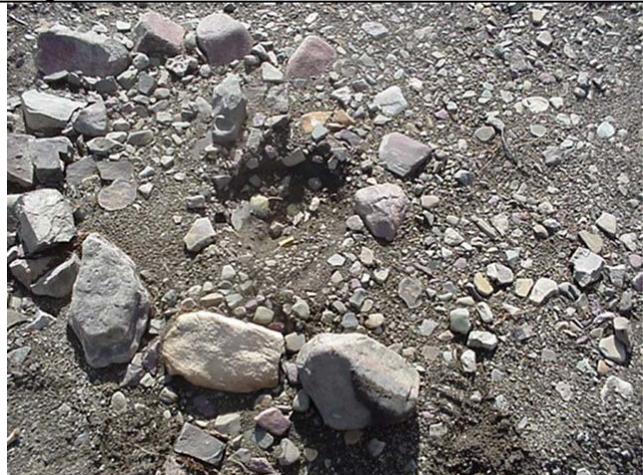
This photo taken in 2001 shows one of the numerous campfire sites (estimated to be up to 1700 yrs old) that are normally underwater, because of the dam. The intake line passes approx. 25' below these sites. The unique construction process utilized and constant project oversight by Owner and IHS insures protection of the site.
